Gilson BROTHERS COMPANY

Service Bulletin #118

Subject: Starting Procedure For Snow Cannon Snowthrower

Service Bulletin #120

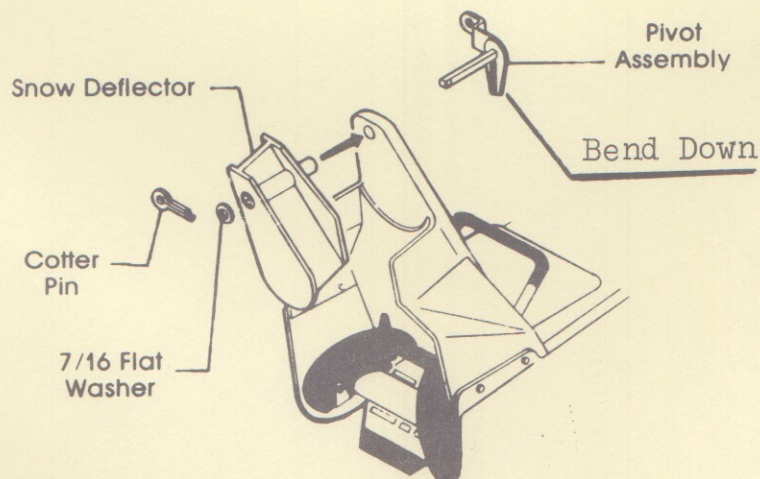
Reports have been received that a small amount of snow blows out between the auger housing and the side of the deflector in light loose snow.

Investigation showed that most of the snow is blowing out between the top of the deflector and the top leading extension of the deflector support.

To reduce blow-by, remove deflector pivot assembly, and bend the top rear detent section of pivot assembly down slightly. Remount pivot assembly and deflector. Clamp deflector tight to top extension housing using two "C" clamps or two vise grips, one on each side of center vane of deflector. Reinstall flat washers removed and add sufficient 7/16" thin washers to take out play between deflector and cotter pin. Install cotter pin, release "C" clamps or vise grips.
