## Service Bulletin #121

Subject: Belt Comes Off Auger Pulley On 2 HP Snowthrower  
(New Belt Finger #209486)

Models: 1850 - 55129 - 55130 - 55179 - 35250 - GIS 7504A97 -  
09GN5139 - 09GN5140

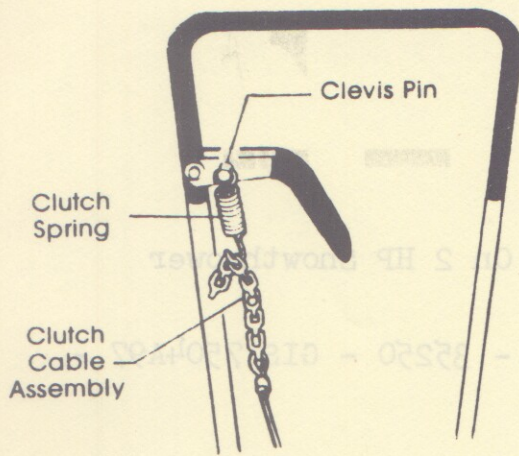
FIG. 1

We have received reports that the belt is coming off the auger drive pulley. Investigation of the problem resulted in finding the following reasons:

1. Improper clutch cable tension. The cable should be slack but not sagging. Change adjustment by hooking 2nd - 3rd or 4th link of chain to spring to obtain proper tension (refer fig. 1).

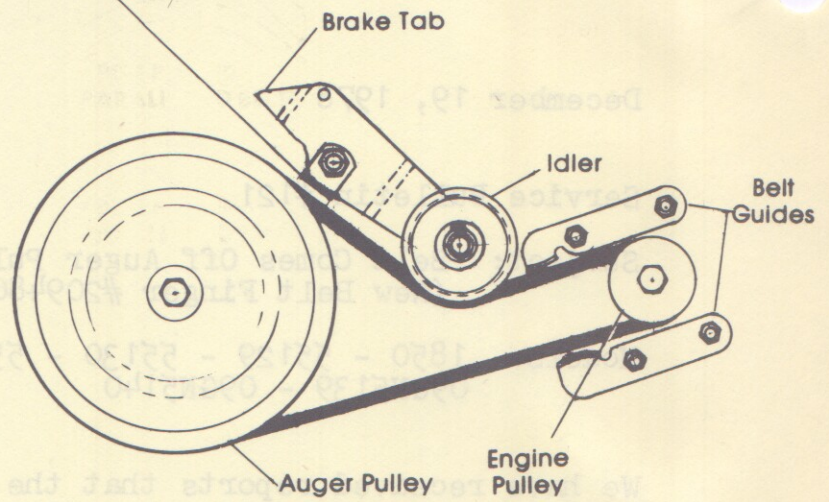
FIG. 2

**NEW BELT FINGER  
(MOUNT PARALLEL TO BELT)**

2. Engine pulley belt guides improperly positioned. The belt guides should be parallel to, and clear the back of belt when belt is engaged.
3. Sudden release of clutch lever causes fast braking action to belt resulting in belt folding and coming off auger pulley. Correction procedure is to install an additional new design belt finger number 209486 at the brake-idler arm pivot nut.

- a) Remove the 5/16-18 hex cone nut and flat washer (discard flat washer).
  - b) Mount number 209486 belt finger in place of flat washer and install cone nut removed above.

- c) Tighten cone nut while holding leg of belt finger parallel to back of belt, when belt is engaged. The belt finger should clear the back of the belt when belt is engaged (refer fig. 2).
